**[Docket No. FAA-2013-0486; Directorate Identifier 2010-SW-031-AD;
Amendment 39-17622; AD 2013-20-16]**

Airworthiness Directives; MD Helicopters, Inc. (MDHI) Helicopters

ACTION: Final rule.

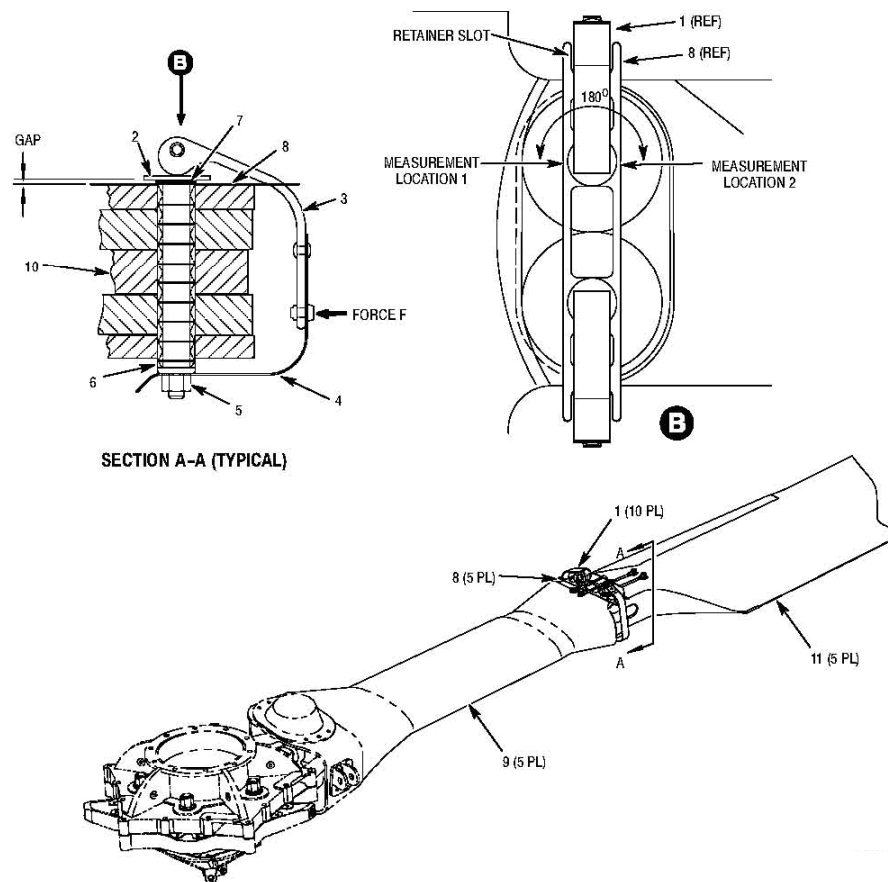
Figure 1 to Paragraph (e)
Gap and Force Check of the Blade Retention Bolts

(i) Visually check each bolt for failure. Failure of a bolt may be indicated by movement of the bolt out of the bolt hole or by inconsistent extension of the bolt above or below the other bolts being inspected (a failed bolt migrates out of the bolt hole).

(ii) Visually check for a gap between the thrust washer and the retainer, P/N 900R2100009-101 or -103. The thrust washer is depicted as item 2 and the retainer is depicted as item 8 in Figure 1 to paragraph (e) of this AD.

(iv) If there is any indication of bolt failure or if there is no gap between the thrust washer and retainer, before further flight, remove and inspect the bolt for a crack.

Replace any cracked bolt with an airworthy bolt.

(iii) If there is a gap between the thrust washer and retainer, measure the gap in two locations, 180 degrees apart, with a feeler gage. If the gap is more than 0.100 inch (2.54 mm) at either location, before further flight, remove and inspect the bolt for a crack. Replace any cracked bolt with an airworthy bolt.
